# Local Road Safety Plan

City of Othello  
Othello, WA

May 2025

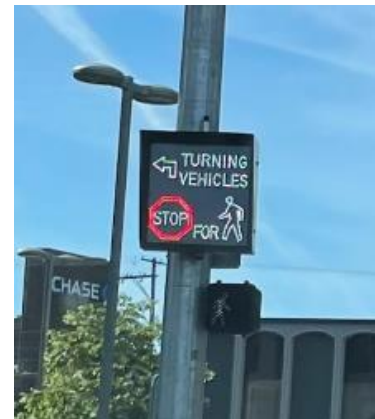
*Left Turn Pedestrian Warning Sign*

4. Consider installation of flashing beacon pedestrian signage along E Main Street at key pedestrian crossing locations. Preliminary analysis indicates that potential improvement locations could include:
